Distance protection in 150/60 kV transformer 60 kV feeders

two real blackout case studies

Bak, Claus Leth; Lind Hansen, Magnus; Nissen, Jens Ole

Published in:
The Journal of Engineering

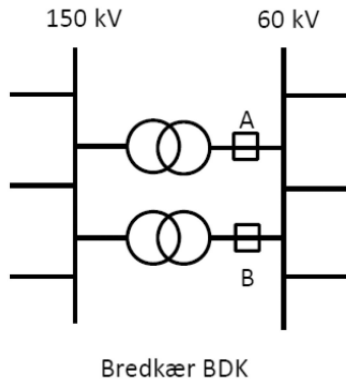
Fig. 1 Single line diagram of two-transformer supply of BDK 60 kV busbar. A and B are distance relays

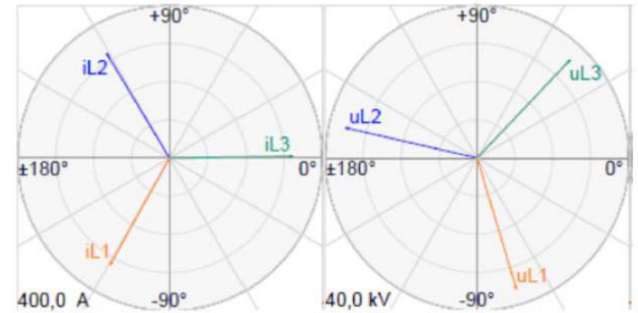
Fig. 4 KT31 currents (left) and voltages (right) at the instant of trip

Using SIGRA fault record current in L3 at instant of trip was $I_{L3trip} = 321.6 \text{ A} \angle 1^\circ$ and phase voltage in L3 $U_{L3trip} = 35.54 \text{ kV} \angle 46^\circ$, see Fig. 4. These are not at all faulty condition values, i.e. current is around one-third of the rated current for the transformer and the voltage is a normal phase voltage. Therefore the first indication is that this is not a faulty condition, but a wrong relay zone setting which has led to the relay tripping for normal load impedance.

$$Z_{\text{fault, prim}} = \frac{35,541 \angle 46^\circ}{321.6 \angle 1^\circ} = 110.5 \angle 45^\circ \Omega \quad (3)$$

Which corresponds to $Z_{\text{fault, sec}} = 184.2 \angle 45^\circ \Omega$ in secondary values. From Fig. 2, it is concluded that the relay detects FORWARD direction. This caused some confusion as the SCADA system at that time showed the power flow to be from 60 kV towards 150 kV. Further analysis showed that the relay was set wrong regarding current transformer polarity due to confusion between being installed in a feeder (where FORWARD is towards line) as being installed in a transformer feeder (where FORWARD is towards busbar). Therefore the measured fault loop impedance (only showed for phase L3) was measured in the FORWARD direction.
